## SAMPLE: FIXING STAGE REPORT

**RE: LOT NO.#, # NAME STREET, SUBURB, VIC CODE**

### The Situation

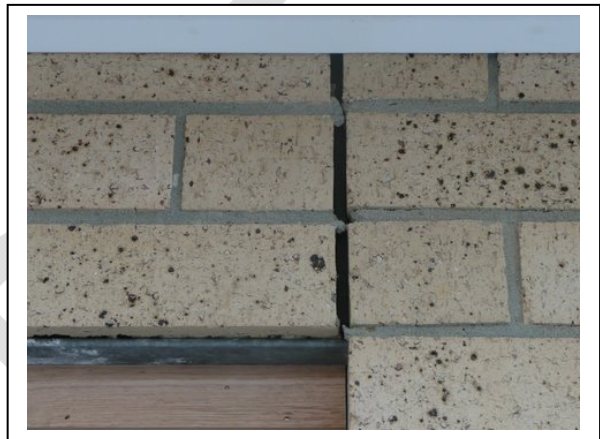
- Expansion joints to brickwork are not filled yet.

Expansion joints to bricks not filled

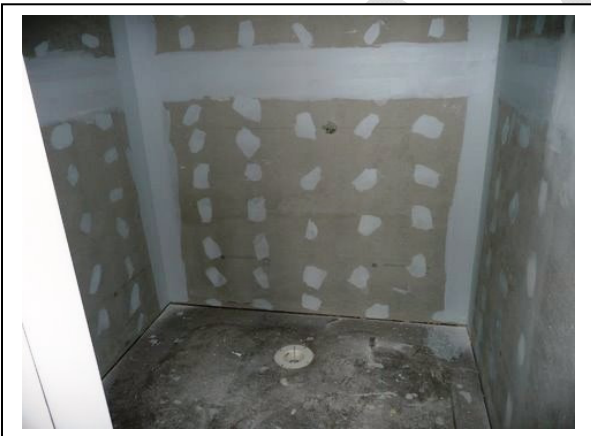
Waterblock sheeting to wet areas

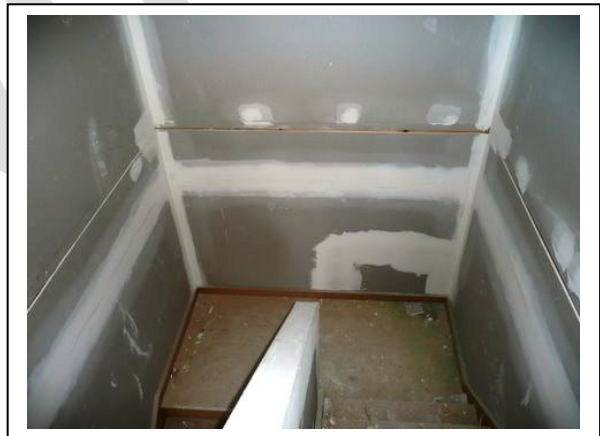
Expansion joint to plaster between storeys

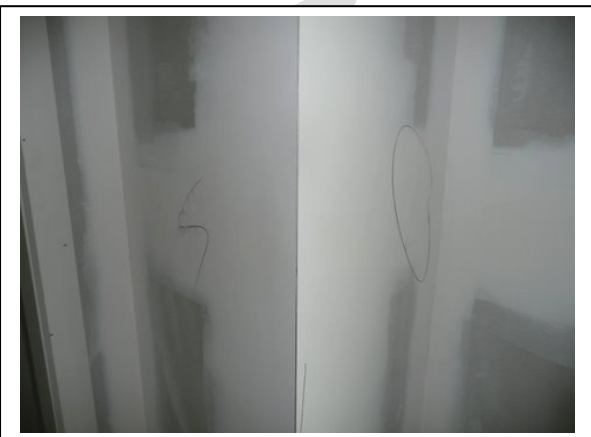
Plaster marked up to show defects

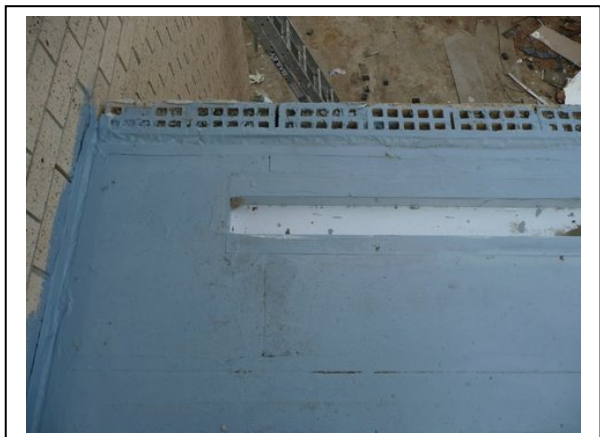
Waterproofing membrane to balcony over Garage

We also advise that any fixings made for balustrades, air conditioning units etc. on the balconies do not compromise the membrane. This will avoid leaking issues in the future.

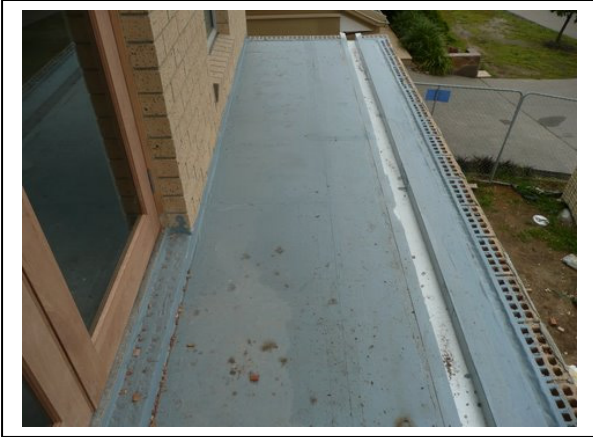
Waterproofing membrane to balcony off Bedroom 1

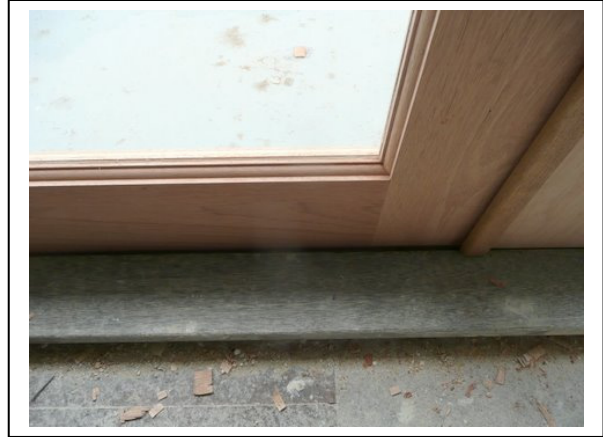
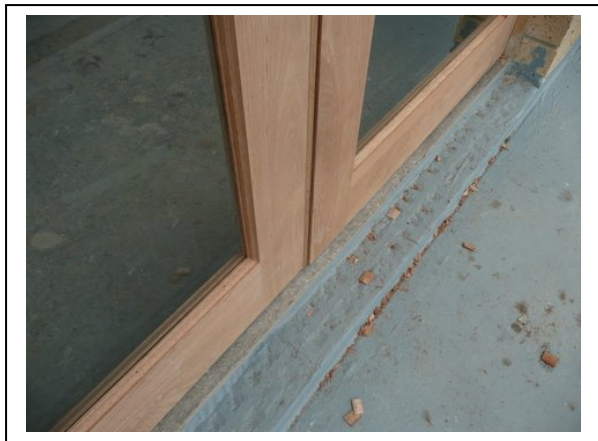
- The left door to balcony from Bedroom 1 is twisted.

Door leaves are defective if, during the initial three months, they twist or bend greater than the limits listed, i.e. twisting measured diagonally across door = 5 mm.

Twist to Bedroom 1 door

Twist to Bedroom 1 door from outside
